Investigation Into a Non Fatal Incident Involving the Fall of a Rope Access Operator

Gold Coast
Queensland
Australia
24th June 2008

Report Commissioned by
The Australian Rope Access Association (ARAA)

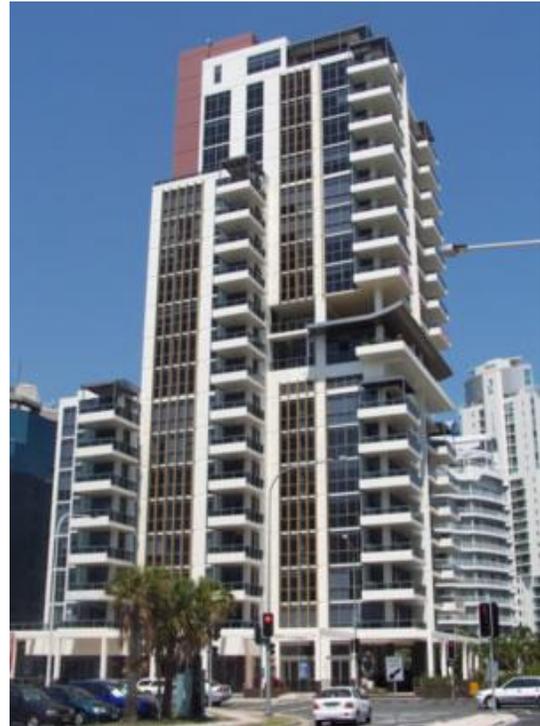
East Face

The structure involved is a 24 storey apartment building. The incident occurred on the east face of the building (see picture at right).

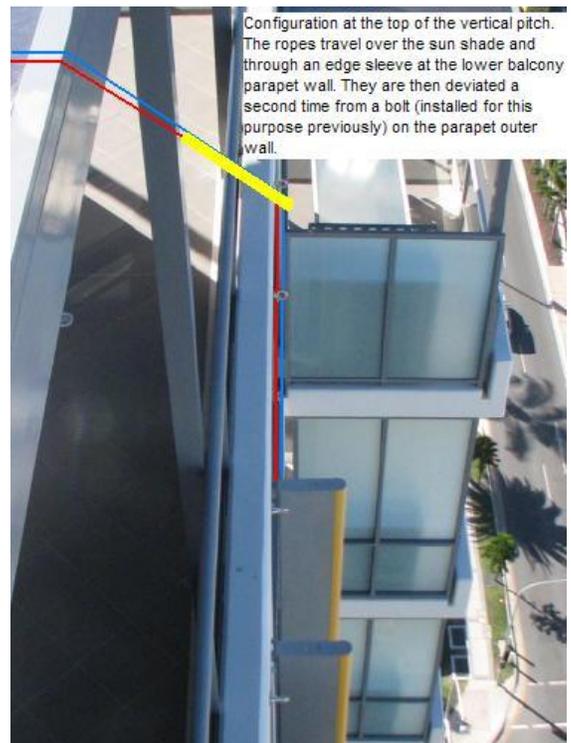
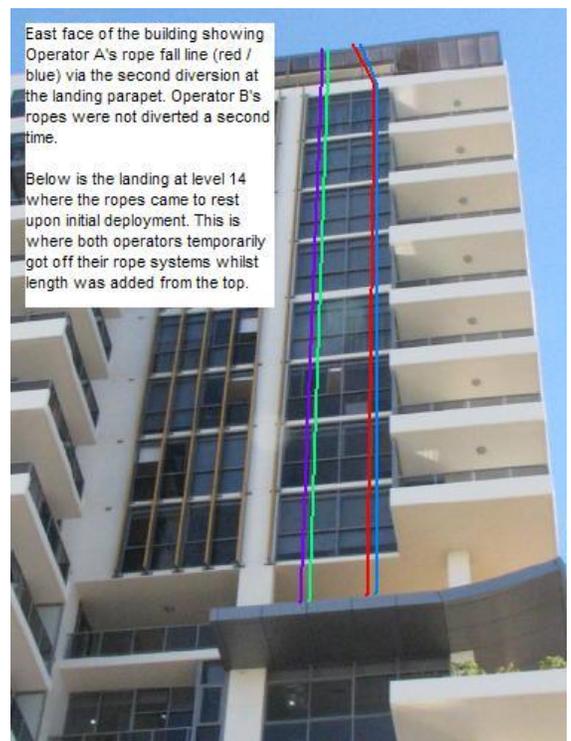
19. Operator A clipped a metal flashing strip on an architectural feature above ground level after his fall

was arrested.

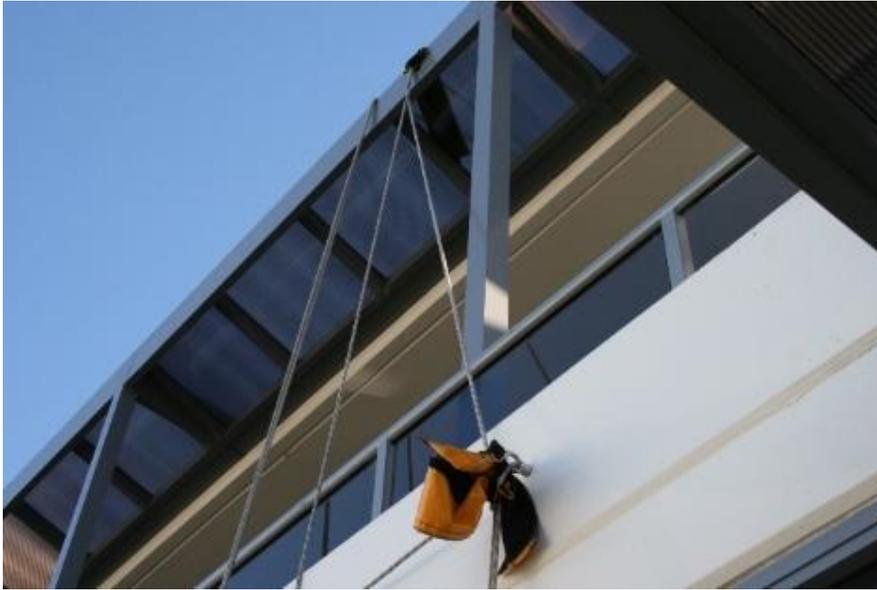
When the rope was lowered over the side (to lengthen the set to make it to the ground), the top rope protector (on the sunshade) that was tied to the rope was lowered onto the lower diverting karabiner on the face of the balcony wall. The rope protector then became caught up and jammed in the karabiner. This then caused the remaining slack rope (that was still being lowered down the wall) to fall in and behind the balcony area.

As Operator A loaded the ropes the 2mm cord ripped out of the attachment loop on the rope protector. This then caused the rope to then pull through the rope protector. The remaining slack rope that was sitting behind the balcony wall was then pulled up and over the small balcony wall and through the rope protector, until all the remaining slack had been pulled through to the anchors.

View of deviation anchor with rope protector clearly shown jammed in connecting carabiner. Note that backup rope has at some point during the incident, flicked behind the adjacent deviation anchor. There is no indication of the backup line or device being loaded during the incident

Edge protection tied to the rope and not to the structure, the edge protection was pulled down into the diverting karabiner when the ropes were lowered. If it was tied to the structure it may have stayed in place on the sunshade.

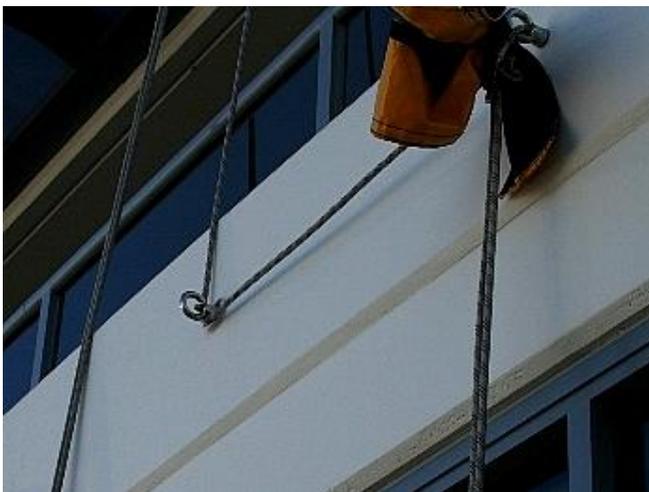
Close up clearly showing backup rope behind adjacent deviation anchor

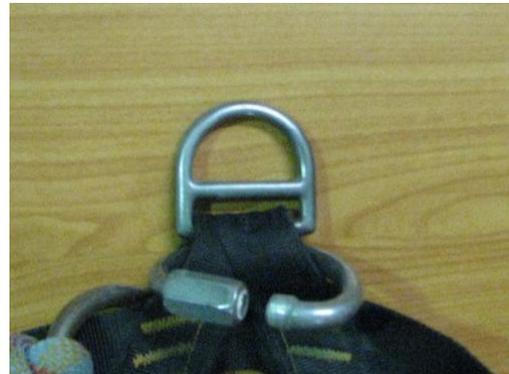
c. Harness – the harness worn by the worker involved was a Rock Empire industrial sit style worn in conjunction with a separate chest harness. The only damage displayed by the harness was where it had been cut from the injured worker by attending paramedics. The waist D ring, which would have bore the brunt of the fall impact, displayed no damage discernable by the naked eye.

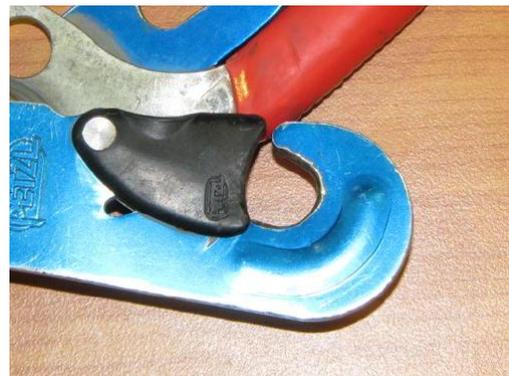
e. B/U device – A Petzl Shunt was in use as a backup device at the time of the incident. The Shunt displayed no damage and still functioned as per normal. At the point of arrest of the falling worker the Shunt appears to have taken very little of the load (see paragraph d. above)

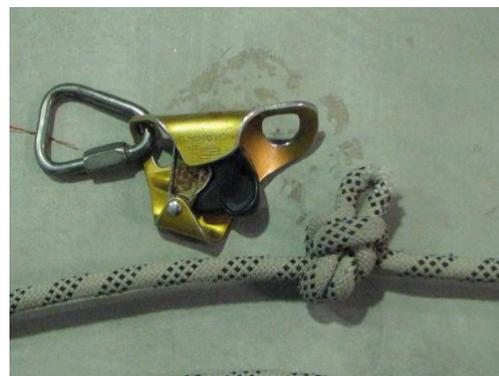
a. Anchor & Knots – The worker’s twin rope system was anchored to two (of four in total) rated & tested eye bolt fixtures installed next to the access way of the roof top block house. The working and b/u ropes were terminated with Fo8 knots and then cross connected using alpine butterfly knots (the standard ‘Y hang’ configuration). Forward of the anchor the trajectory of both ropes was changed by a fairly obtuse deviation (probably exceeding 120°) and then below the structural sun shade feature was changed again via a ring bolt deviation (the bolt being located on the outer side of a parapet wall). Below this second deviation was an alpine butterfly installed by the operator in order to isolate out a damage point in the working rope. The exact position of this alpine butterfly relative to the second deviation (after the extra rope was added into the system by the rooftop operators) is unknown. The picture at right shows this knot and the extreme capsizing and cinching that has occurred. The Croll is orientated in the direction the alpine was orientated at the time of the fall i.e. left / up.

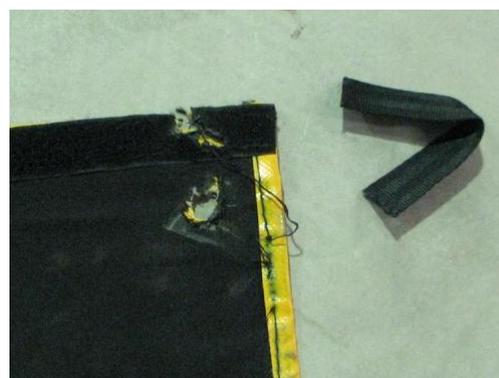
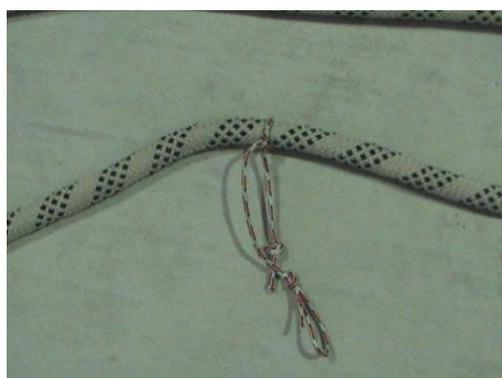
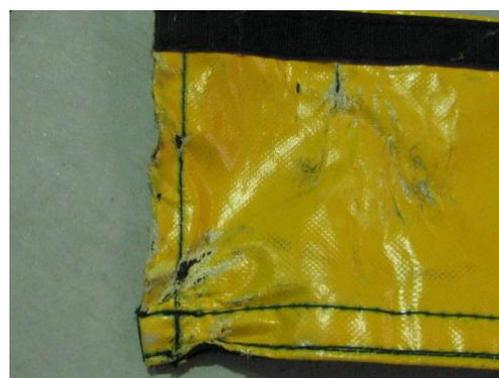
b. Edge Protection – A Cordura / PVC Velcro closure rope sleeve was installed on both ropes at the point where the lines cleared the top edge of the lower parapet/sunshade and were deviated a second time. The sleeve was attached to the working rope with a small length of 2mm accessory cord (below) to keep it in place. The edge sleeve was burned and damaged by the working rope travelling through it at high speed during the unrestrained fall of the injured operator (left and lower right).
