## I Third Degree Burn Sustained During Rope Access Hot Work

## 2 LTI – Severed Tendon

### 3 Minor Chest Burns Suffered by Rope Access Technician

### 4 Near Miss: Safety Device (Hard Link) Damaged During Hot Work

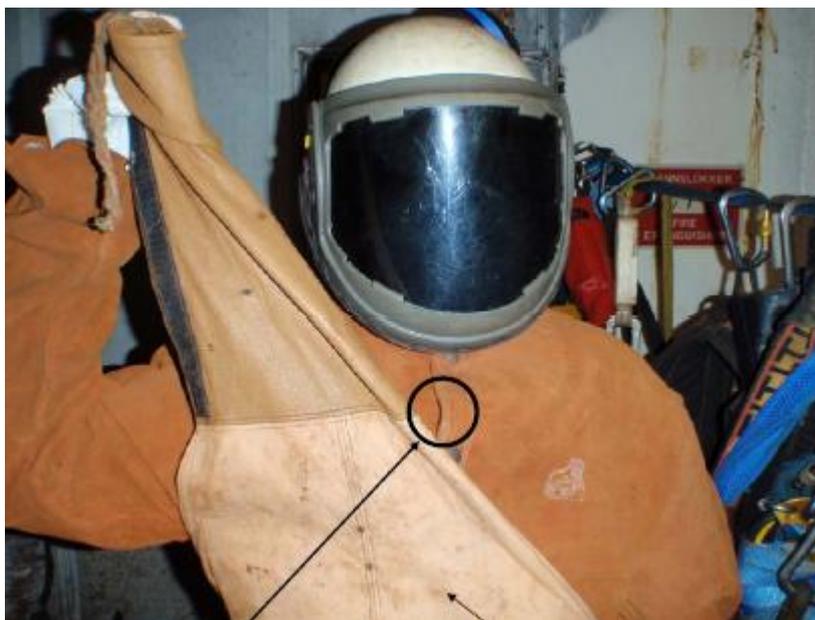
A member has reported an incident in which a rope access technician suffered minor spot burns on the chest during cutting operations. A 24 inch pipe approximately 4 metres above the deck was being cut by the rope access technician (RAT), who was suspended by rope access gear and also standing on a ladder. The first cut and the access hole for a shackle, using a standard cutting torch, went smoothly. The internal pipe was covered with a 4 centimetre thick rust layer. When the second cut was nearly completed, some melted particles of rust fell onto the tip of the cutting torch. One of the particles from the tip of the cutting torch was blown away and somehow entered into/below the RAT's protective clothing. The technician felt some very light pain on his chest and continued to work. After shift the technician felt some minor irritation on his chest and sought first aid. Three small burns on the middle of his chest were treated/covered by one plaster.

- ◆ The direct cause of the incident was molten particles entering through an opening between the buttons of a fully closed leather protective jacket. This personal protective equipment (PPE) was not giving full body protection.

Figure 1 - Protective clothing for rope access technicians showing small opening through which hot particle passed

- ◆ Protective jackets used for hot work should close using "velcro" closing straps rather than buttons;
- ◆ Consideration should be given to different kinds of protective clothing, including flexible fireproof hoods designed to cover shoulder, chest and neck area;
- ◆ It should be emphasised at toolbox talks and in preparation for hot work that molten particles can enter PPE through the smallest openings.
